Thermonuclear Damage to Wall Materials in a Dense Plasma Focus

L. RAYMOND, G. M. MOLEN, G. G. COMISAR, and C. T. YOUNG
Materials Sciences Laboratory
The Ivan A. Getting Laboratories
The Aerospace Corporation
El Segundo, Calif. 90245

15 December 1977

Interim Report

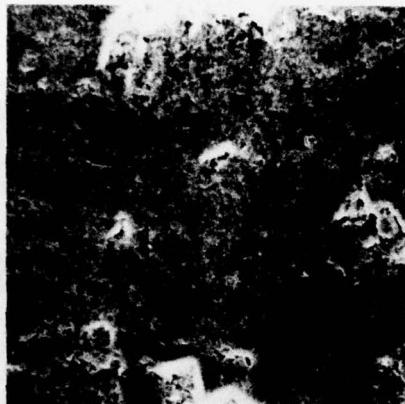
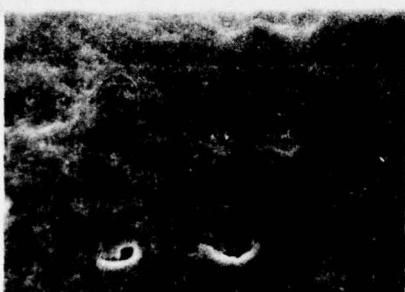
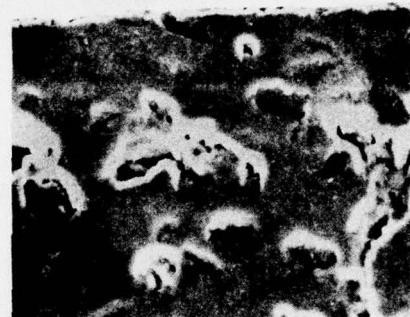
The graphite liner was affected primarily by erosion, which was the result of surface sputtering and which caused grain-boundary cavitation. This cavitation, resulting from ion etching by an incident deuteron beam, produced some surface cracking. In this case, the surface cracking was considered to be minor, although it could eventually cause spallation of the graphite particles into the plasma. The surface of the graphite is shown in Fig. 7 before and after exposure.

Fig. 7. Sputtering in Graphite Liners with Grain Boundary Cavitation After Single Discharge
